# BUREAU OF SHIPS GROUP TECHNICAL INSPECTION REPORT

⑥ OPERATION CROSSROADS.  
U.S.S. CONYNGHAM (DD371)

TEST ABLE [U].

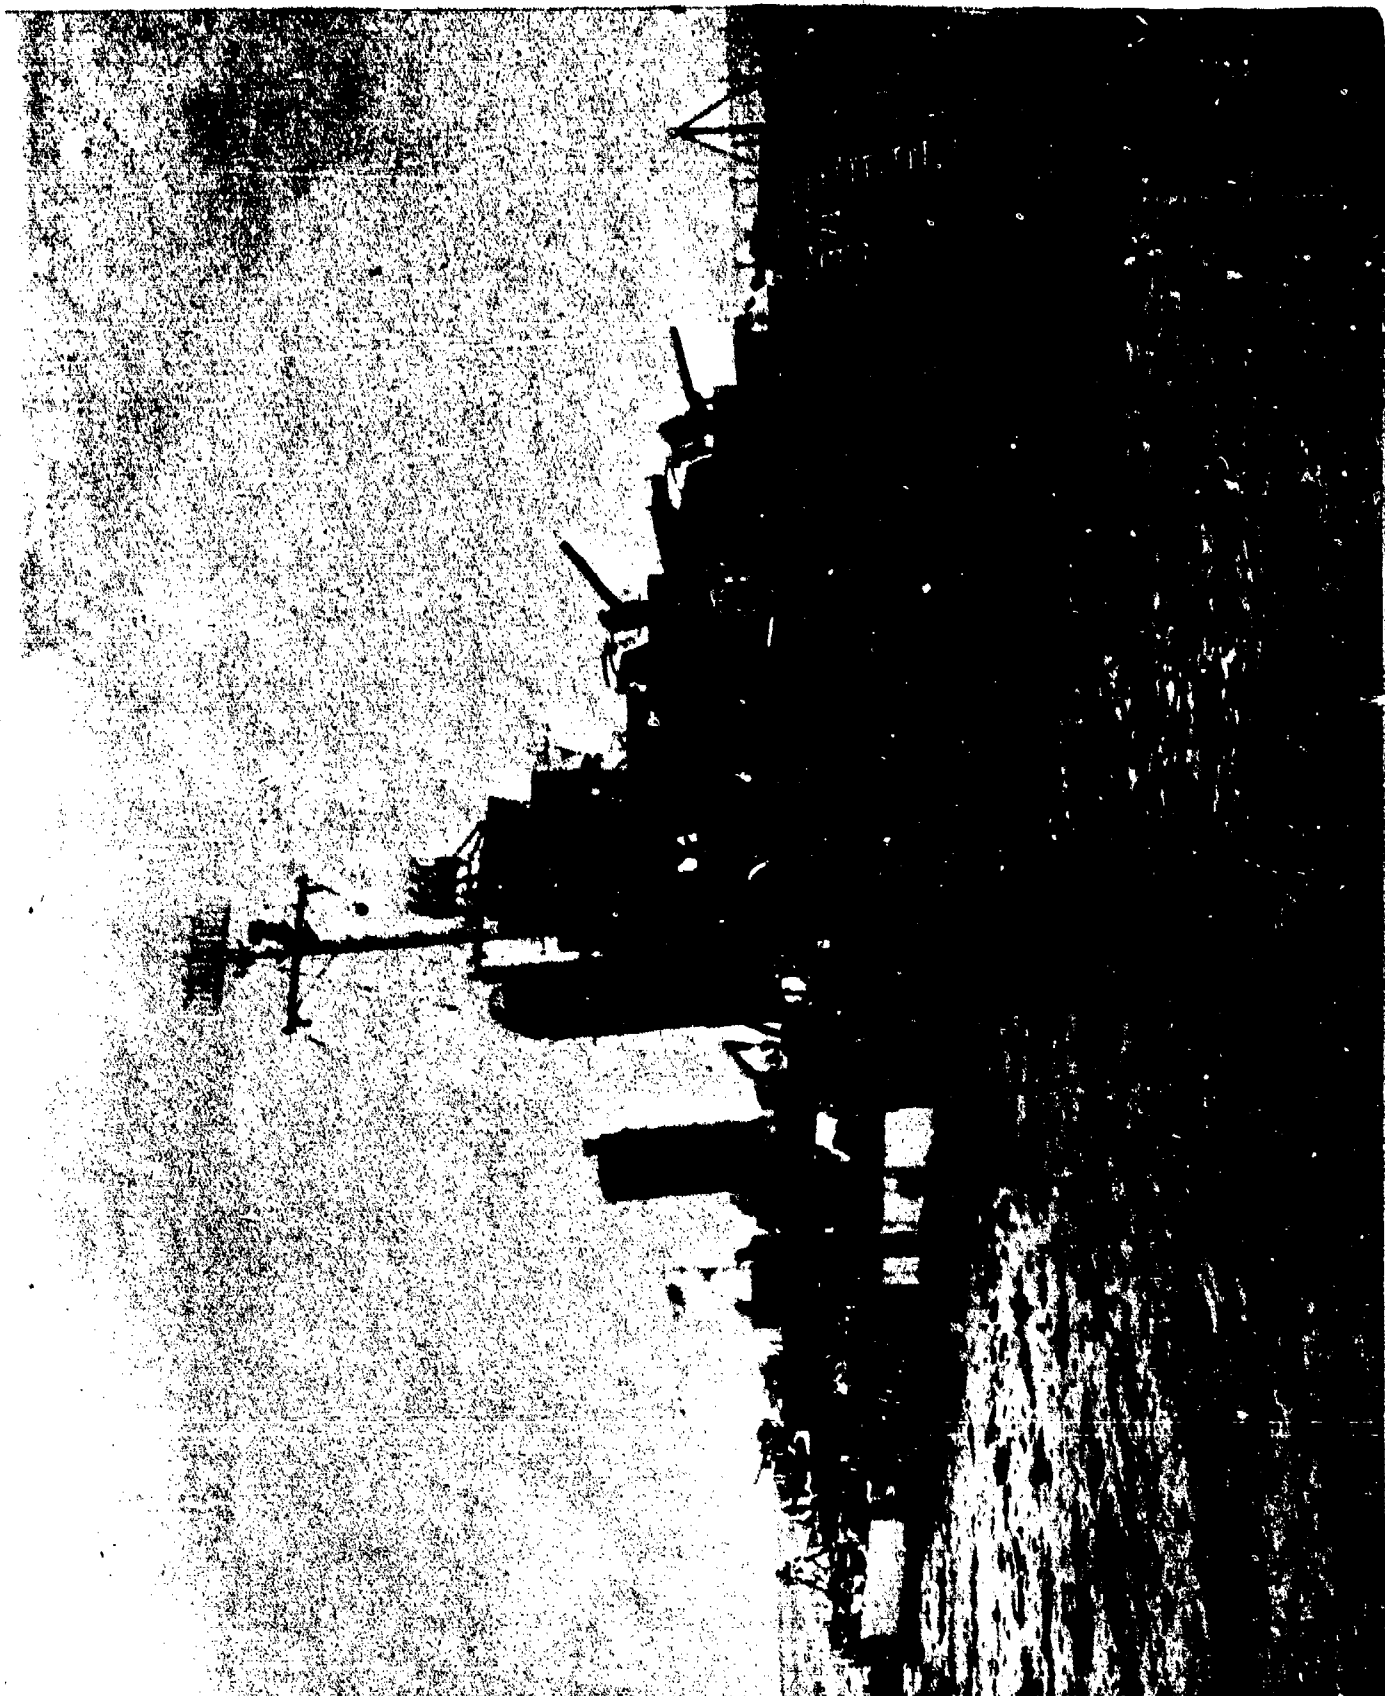
AA-CR-227-87-59. View from off starboard bow. (Spotting and re-painting of shell started.

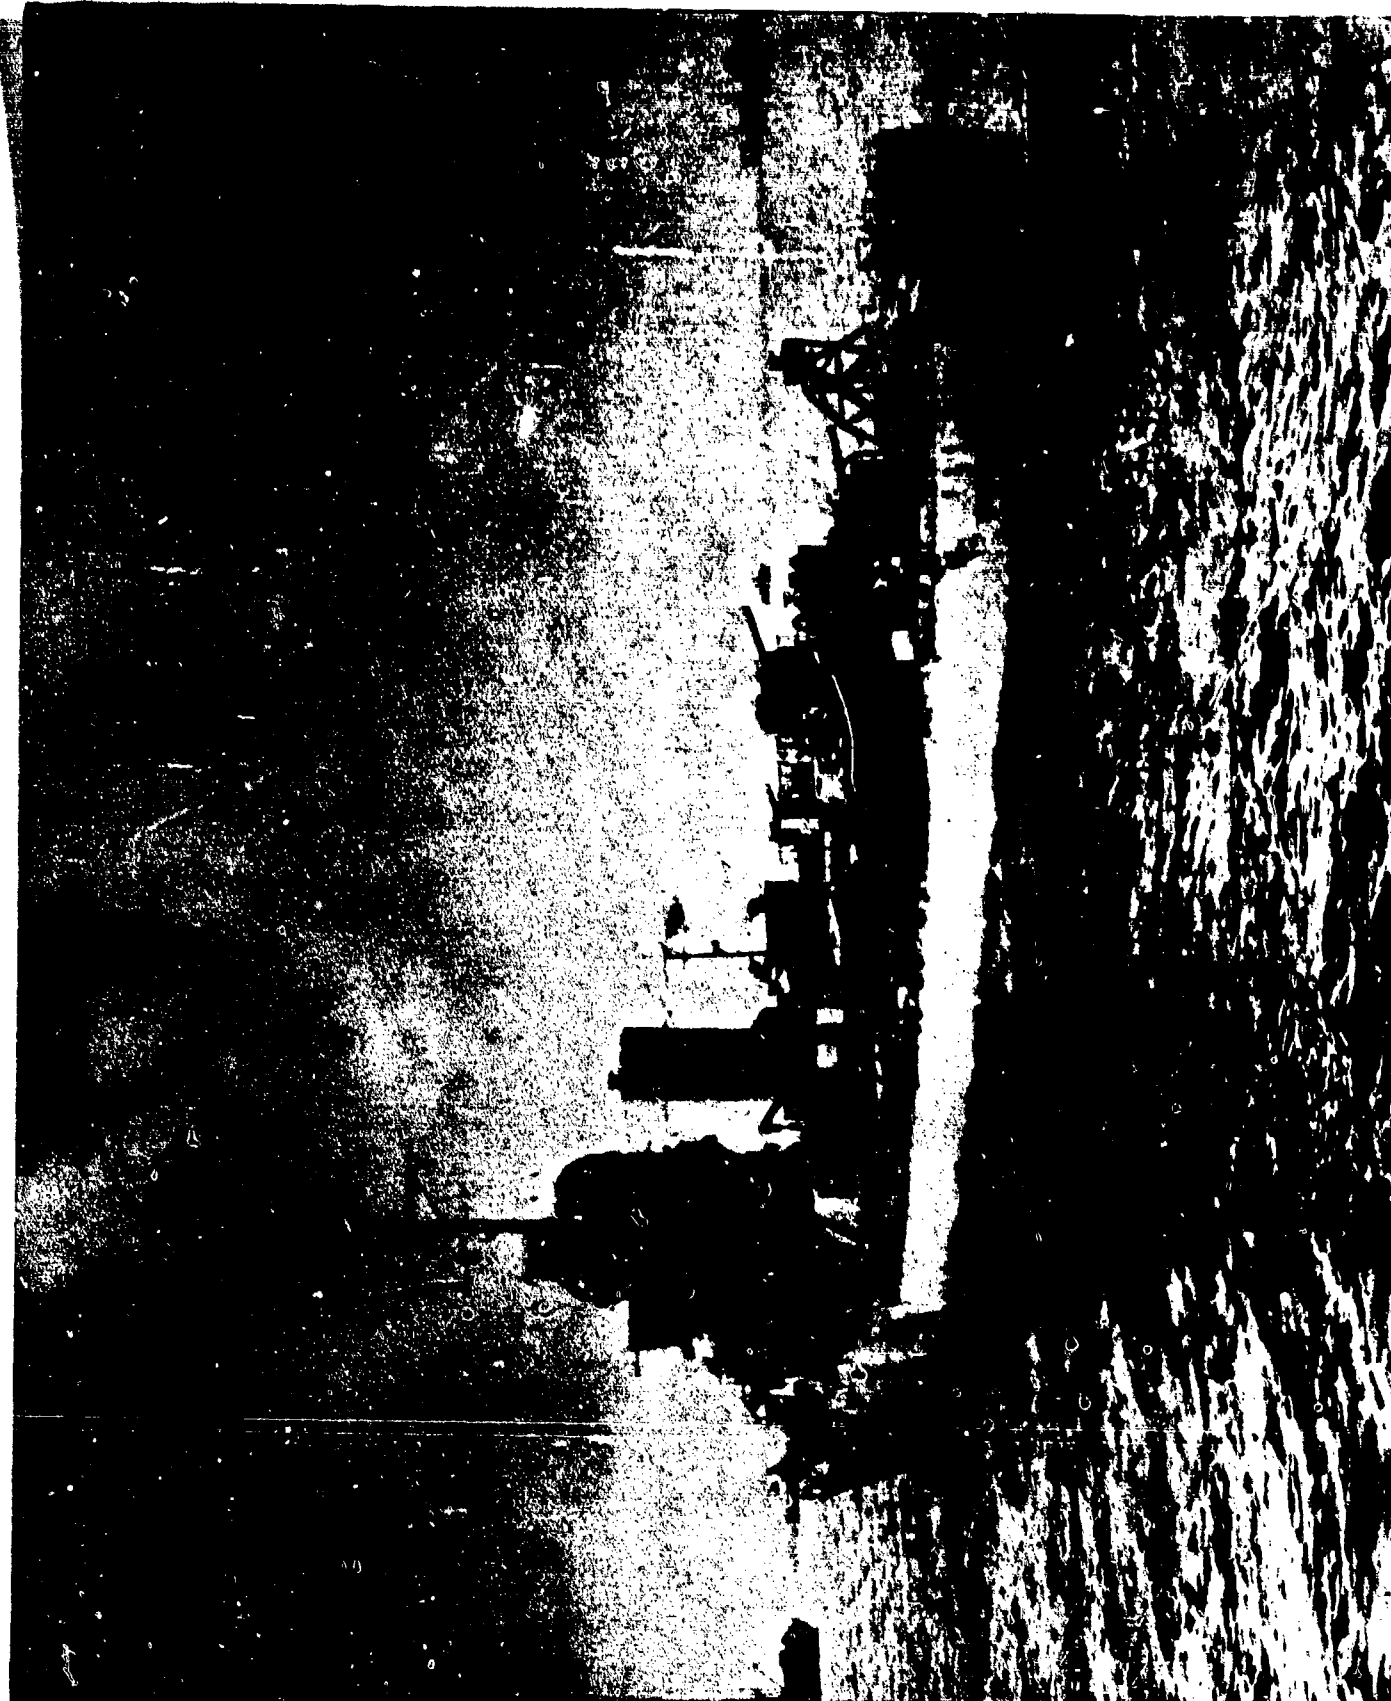
AA-CR-227-87-56. View from off port quarter. (Repainting of shell started.)
